## How to Maintain and Restore a Deck Showing Uneven Wear

### Deck Case Study

**Deck Situation:** A southwest facing, 1,200 square foot cedar deck in London, Ontario, Canada, was finished with one coat of Sansin Dec in Espresso and one coat of SDF Topcoat Espresso in April 2016.

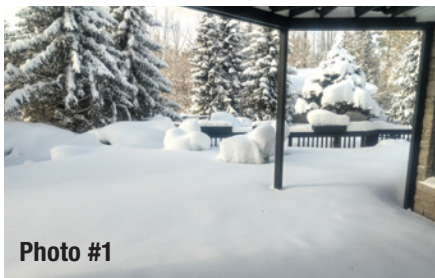
Photo #1

Sansin’s Dec product is a penetrating finish that works well for wetter wood situations. Normally, Dec is a 2-coat system. However, in this instance, the owner wanted a fuller finish and therefore, selected Dec as the first coat and SDF Topcoat as the finish coat. This deck ranges from sitting on ground level to a maximum clearance of 12” from

ground level in an area (London, Ontario) that is considered an extreme climate for decks. It lies at the latitude of 42.5 degrees near to the Great Lakes, which brings large seasonal temperature and climate contrasts with lake effect moisture and snow. **(Photo #1)**

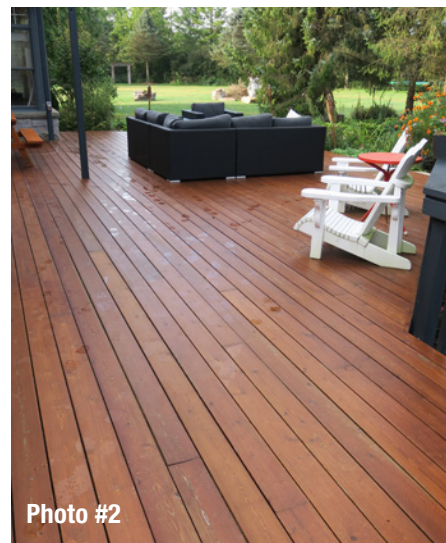
Photo #2

### Maintenance Inspection:

noticed. It was clear by May of 2018 that a simple maintenance coat would be necessary to protect these newly opened surfaces.

As it turned out, to the owner's regret, the maintenance of the deck was put off until September of 2018 **(Photo #2)**. That meant the deck was into a third season of sprinkler wear and tear.

While 95% of the surface still looked great, the area that was wetted daily had started to discolor around the tiny checks. Also, some areas near the end grain were showing signs of moisture intrusion and

swelling and contraction. **(See Photo #3)** Had the deck been maintained in Spring of 2018, then a maintenance coat would have been sufficient. Waiting just four months longer caused two areas to need more corrective treatment, turning a half-day job into a two-day job.

The plan now was to both 1) correct the high wear areas that were left too long, 2) and maintain the other areas with the normal maintenance coat using SDF Topcoat.

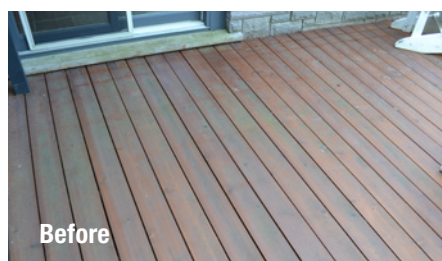
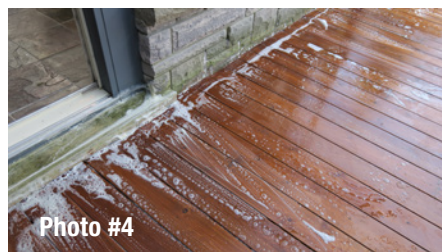
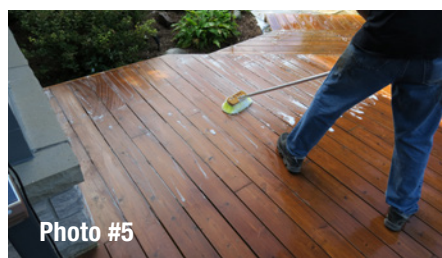
Once the cleaner has been applied for the recommended period of time, rinse off the deck with a hose. Use a lot of water, but then let the deck dry thoroughly. **(See Photos #4 and #5)**

For maintenance coat preparation, the owner used Sansin Multi-Wash. You can apply Multi-Wash with a scrub brush.

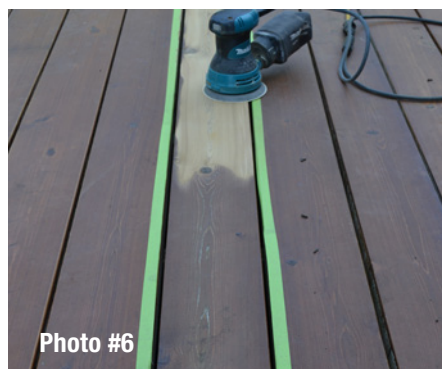
Before putting a maintenance coat over the entire surface, it was evident that one cedar plank was showing more discoloration around little cracks from excessive moisture (swelling and contraction) or insufficient coating. **(Photo #6)** the decision was made to redo this board that showed signs of wear down the middle of the wood. The grayer wood

and slight yellowing show that insufficient coating was applied. This can be due to improper preparation or application, or sometimes a board can be of poorer quality and wear faster. In this instance, the owner can't spot treat, but will instead sand the board down to bare wood with 60-80 grit paper and refinish that board with Dec and SDF Topcoat.

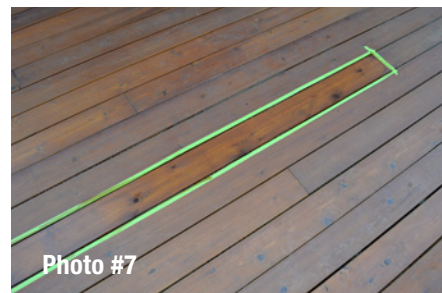
Once the entire deck is top-coated, it will

blend and you will not be able to notice a difference in color or clarity. **(Photo #7)** On other areas, a spot treatment was necessary. One area was damaged by a sprinkler that drenched certain boards, leading to discoloration and calcium deposits from water pooling. In this heavily wetted area by the sprinkler it was clearly visible which end grain surfaces were not protected. The end grain of wood absorbs moisture more than twenty times faster than perpendicular to the grain. It is important to protect end grain properly.

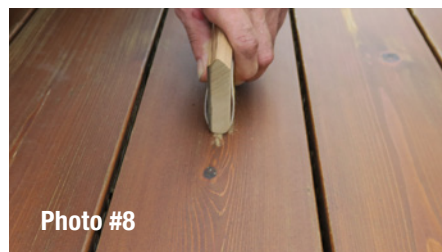
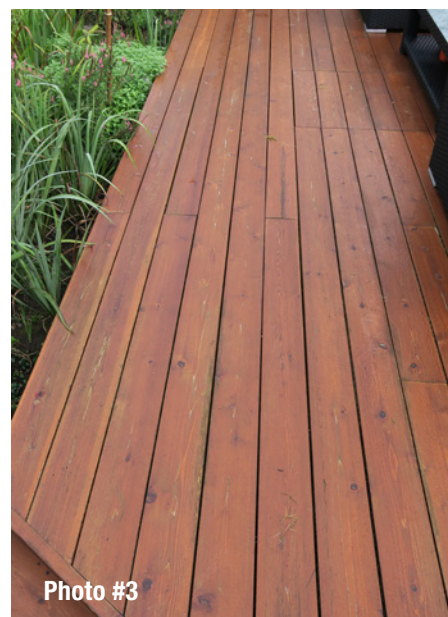
After carefully sanding the specific spots with 60-80 grit sandpaper **(See Photos #8 and #9)**, Dec Espresso stain was applied directly to those bare areas with a China bristle brush **(Photo #10)**.

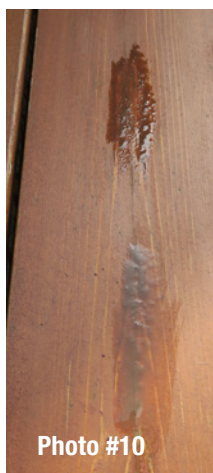
Photo #10

Using a strong color formula would better match the color as penetration is less when scuff sanding compared to random orbital sanding. The product was

left to stand wet and soak into the bare wood because applying to the point of refusal would match the color with the previous applied products.

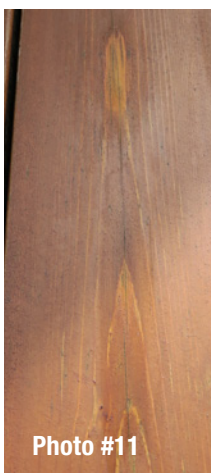
Photo #11

After letting it sit, excess product was brushed away, leaving about 4-5 wet mil of Dec remaining **(Photo #11)**. They were careful to wipe product away from the intact coating around the bare spot.

The newly stained area was then scuff sanded (220 grit) to prepare for the SDF Topcoat. This coat was applied in a similar way to the first, but allowed to blend in to the surrounding, intact coating area.

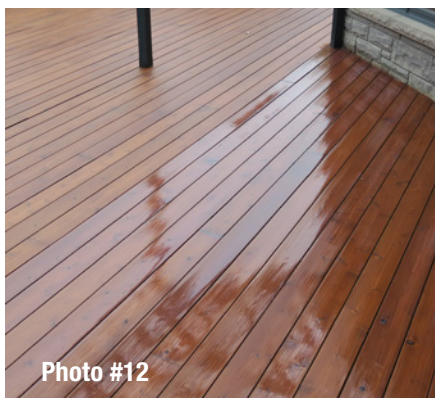
Photo #12

Now that the corrective staining was complete, a maintenance application of SDF Topcoat was applied to the entire deck. SDF Topcoat was applied with a 6" Corona brush. **(Photo #12)**

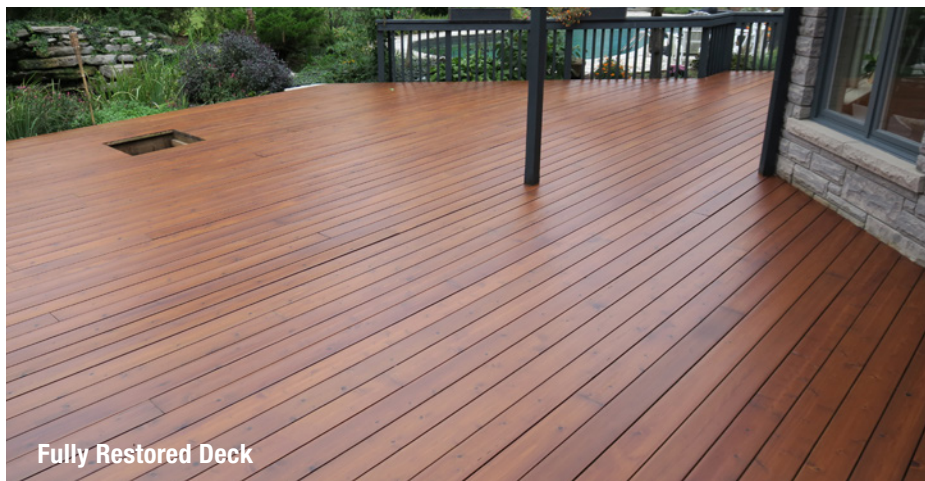
Fully Restored Deck

The completed cedar deck is now ready for two or more years of protection. The owner will now be more careful about ensuring the sprinkler system does not hit parts of the deck leading to faster wear – and keeping the gutters clean.
